# **Pulverised Fuel Ash and Preventing the Thaumasite Form of Sulfate Attack**

**Lindon K A Sear<sup>1</sup>**

<sup>1</sup>Technical Director, United Kingdom Quality Ash Association, Regent House, Bath Avenue, Wolverhampton, West Midlands, WV1 4EG, UK.

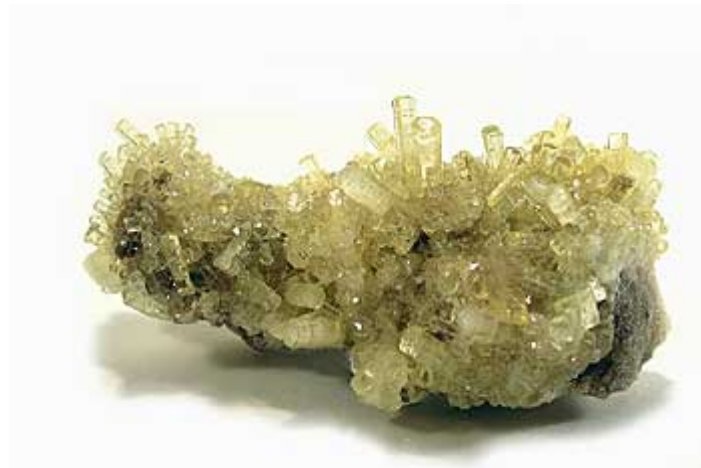
**Figure 1 – A specimen of naturally occurring thaumasite**

Thaumasite is a naturally occurring, though rare, mineral found in metamorphosed rocks that have undergone hydrothermal change, see figure 1. The formula is generally accepted as  $\text{CaSiO}_3 \cdot \text{CaCO}_3 \cdot \text{CaSO}_4 \cdot 15\text{H}_2\text{O}$  and its formation only occurs at lower temperatures. Bensted and Varma<sup>1</sup> in 1974 reported on the structure, properties and methods of detecting this mineral in detail. Because its structure is similar to that of carbonated ettringite many incidents of sulfate attack have probably been assigned to 'normal' sulfate attack rather than to thaumasite. However, ettringite formation results in expansion, whereas thaumasite destroys the cementing components, forming a soft, powdery material.

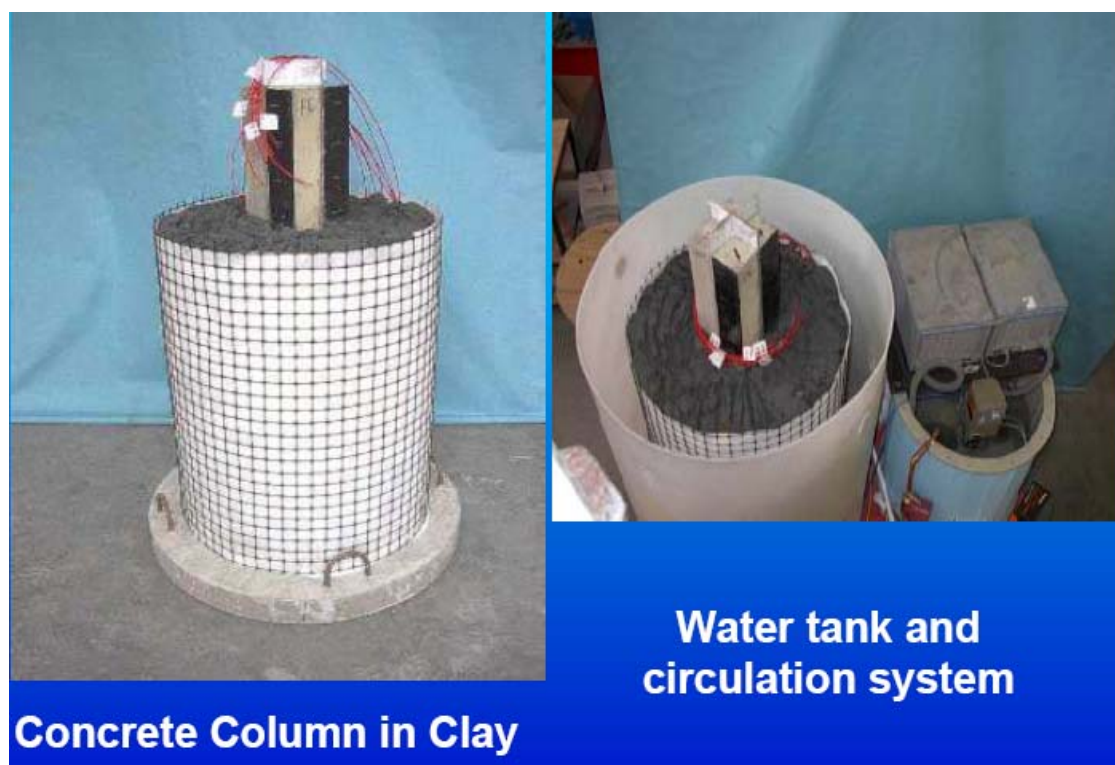
**Figure 3 – Byars, Cripps et al, Sheffield University simulation of concrete exposed to pyritic clay**

Byars, Cripps et al<sup>11</sup> from Sheffield University, between 2000 and 2003, looked more specifically at whether sulphuric acid attack was a precursor of thaumasite attack. They investigated the chemistry of the pyritic clays when exposed to oxidation, whether they could produce a significant amount of acid to dissolve the concrete. As it transpired, the natural carbonate within the pyritic clays was more than sufficient to neutralise oxidised pyrites, however, this did result in readily available carbonic acid. In addition they reproduced a range of concrete mixes in a variety of sulfate conditions held at 5C. The cementitious types were ranked in the following order (poorest first); Portland cement, Portland Limestone Cement (20% Limestone), Portland Fly ash (25% fly ash), Sulfate Resisting Portland Cement and Ground Granulated Blastfurnace Slag Cement (65% GGBS). However, a further test was carried out using a column made of the four main cement types using pyritic clay surrounding it in a pseudo real structure again held at 5C as shown in figure 3.

In this case the PLC suffered very quickly, deteriorating significantly after 6 months, whereas the other cementitious types were not damaged. It is interesting to note in these latter tests one surface of the concrete was coated with a simple bitumen coating. No attack occurred to this section of the specimens.

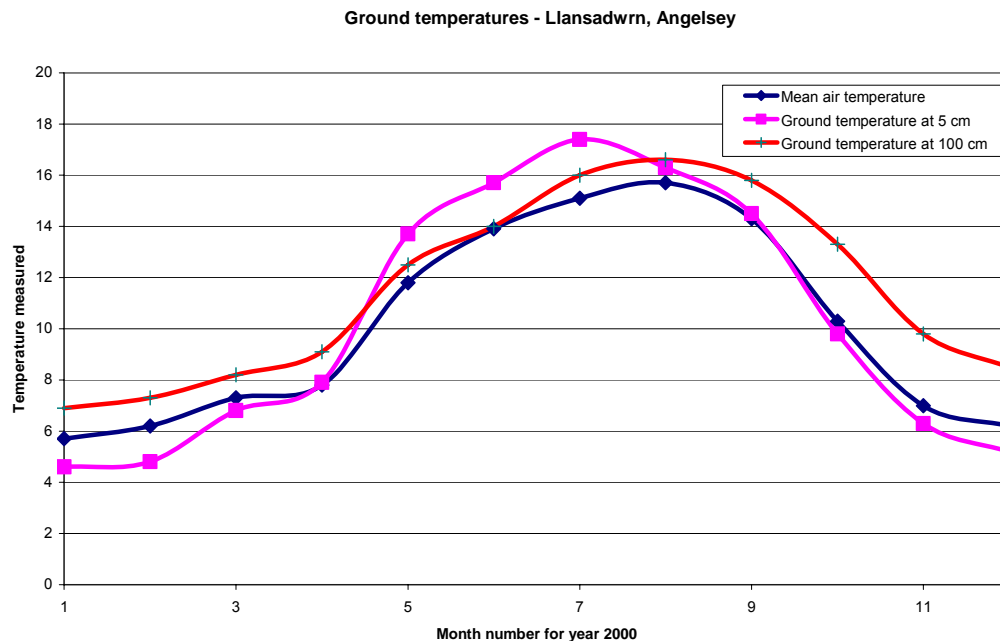
Figure 4 shows the measured ambient and ground temperatures found in the UK, in this example in North Wales. It is clear the temperature averages around 12C with only three winter months with 5C at 5cm below the ground surface being the norm. It is clear the use of 5C in the laboratory is very artificial and would probably accelerate deleterious reactions like thaumasite.

**Figure 4 – Typical ambient and ground temperatures found in the UK**
